‘Appropriate technologies’ in the conservation of cultural property

Protection of the cultural heritage
Technical handbooks for museums and monuments 7

The Unesco Press

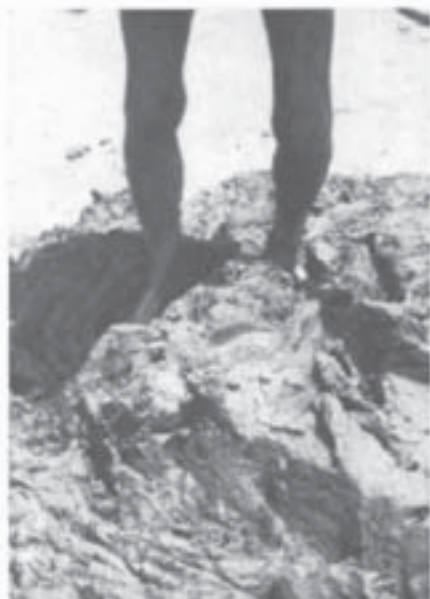
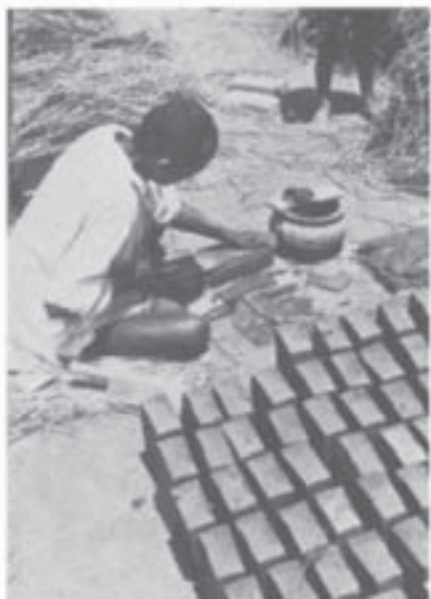
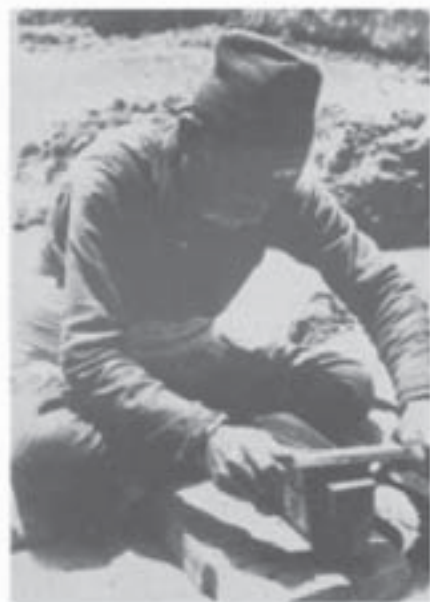
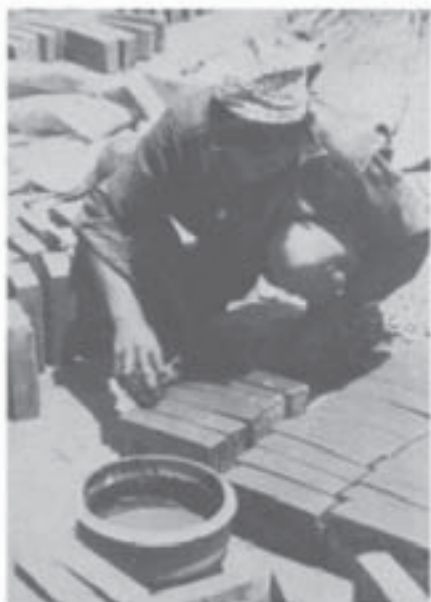
The stages of making the special *telia est* brick:
 (a) preparing the clay; (b) shaping the brick;
 (c) preparing the face; (d) slip glazing prior to fir-
 ing [Photo: Unesco/J. Sanday].

able. The clay is then thrown into a wooden mould which is slightly larger than the final brick size, thus permitting approximately 10 per cent shrinkage in firing. The average size of a fully burnt brick is $8 \times 2 \times 4$ inches. The brick is turned out on a bed and left to dry for one day in the shade, after which it is firm enough to be handled. The next stage is for the brick to be shaped. The brick is squared up to a depth of two and a half inches, a suitable face is selected and flattened with a heavy mallet, causing the face to spread under impact. The brick is then trimmed with a scimitar-shaped knife and a straight edge to form the sharp arrises to its face. During this process the brick is cut to a wedge, after which the face is whetted with a small flat piece of timber or stone to achieve a uniform surface. The brick is then left to dry for five to eight days, after which the slip glazing process begins. The clay used for the glazing is taken from a special seam in a small village on the outskirts of Kathmandu called Hadegaon. The clay is excavated, cleaned of all rubbish, well kneaded and then stored beneath sheaves of paddy straw throughout the monsoon. During the rains, the straw produces a microscopic fungus growth like a fine red dust which is washed into the clay by the rain, thus giving it colour and texture. After a certain period it is stored in a godown to mature for six to ten years.

of the brick. This is then burnished with a haematite stone, which gives the brick its lustre, after which it is left to complete its drying process. The longer it is left before being subjected to the heat of the kiln, the less it is likely to crack when it undergoes violent contraction during firing.

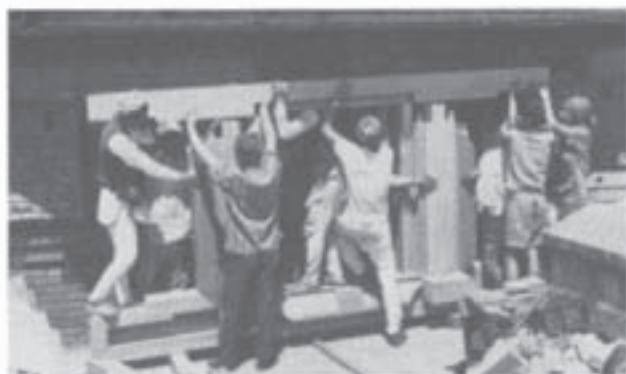
The fitting of the lintel to the carved window
[Photo: Unesco/J. Sanday].

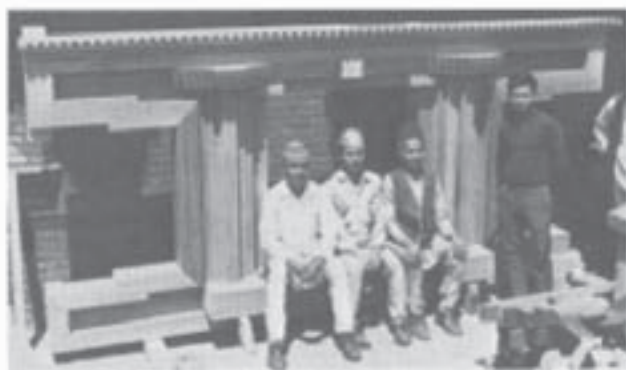
The carpentry work now complete, the window is
ready for carving [Photo: Unesco/J. Sanday].

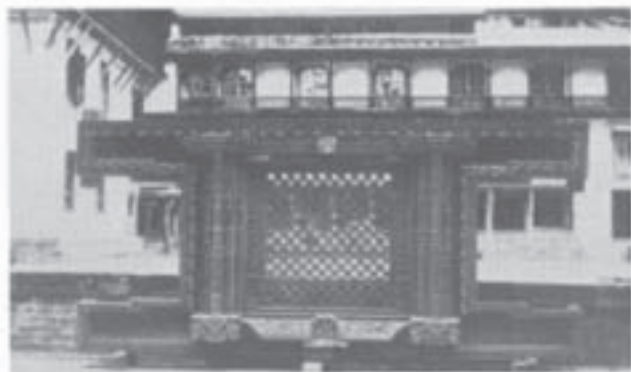
The carved window nearing completion [Photo:
Unesco/J. Sanday].

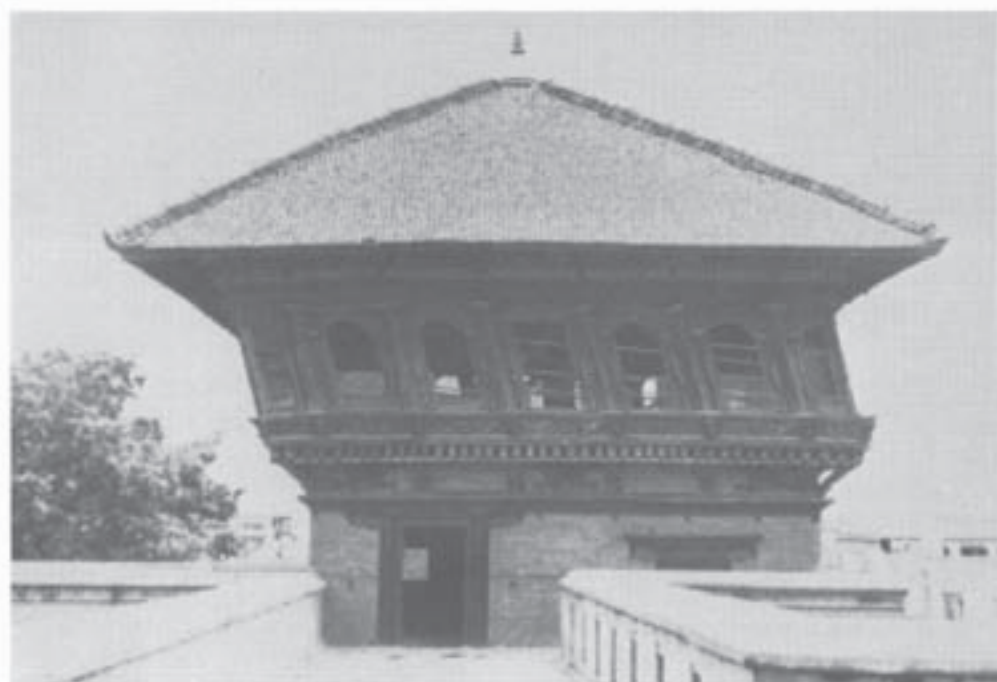
The Lalitpur Tower—before and after renovation [Photo: Unesco/J. Sanday].

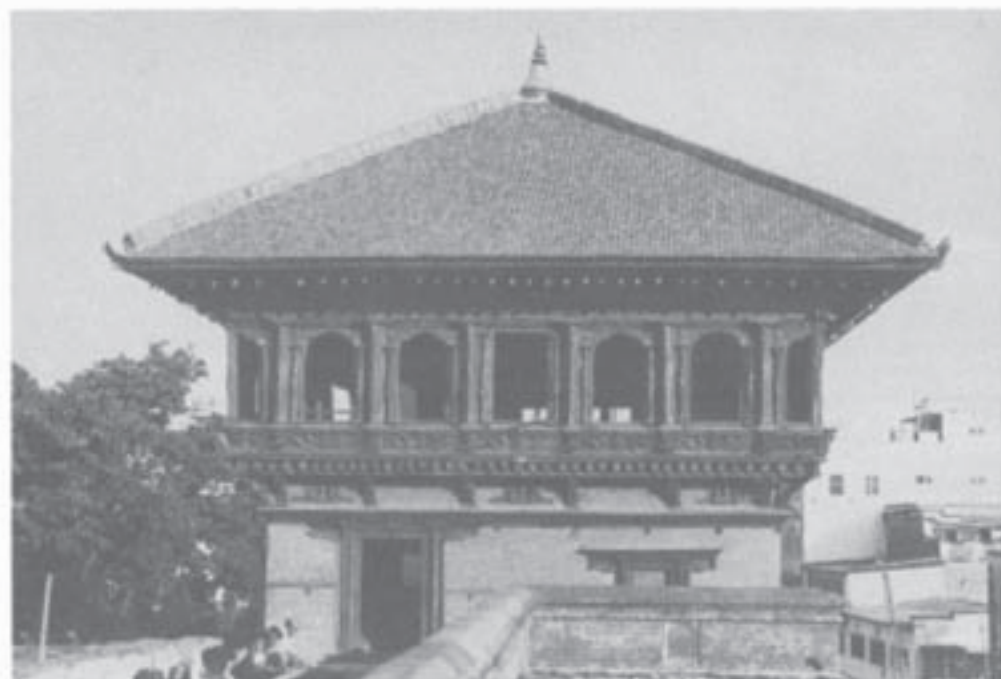
The roof was replaced using over 90 per cent of the original structural members which had been duly referenced, only for it to be discovered, once they were cleaned, that a previous numbering system in Newari had been used. Various key joints that had become loose were strengthened with iron clamps or braces, and timbers that had been lengthened by using scarf joints were replaced where possible using a single length.

and conservation techniques which had been tested and proved to be both practicable and successful in Stage 1 were used again to complete the work on this tower and the final result is a fine tribute to the craftsmen who worked on its renovation.

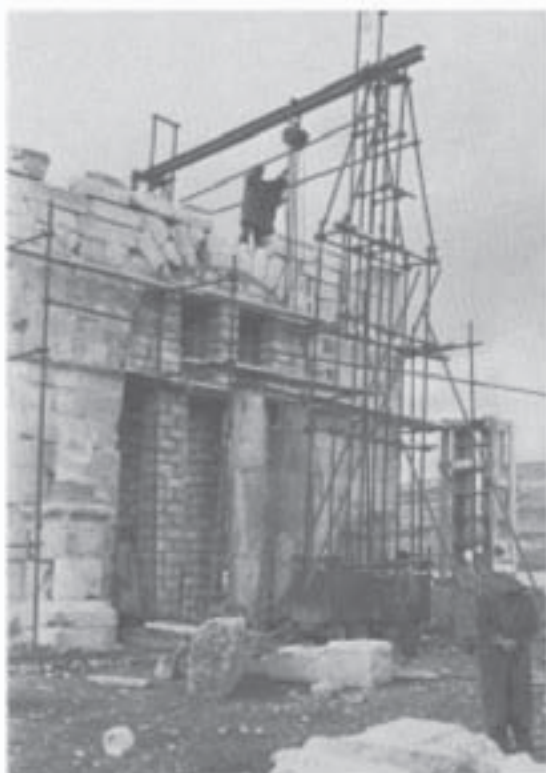
Reconstruction of columns—filling in with concrete [Photo: J. Vêrité].

To replace the stones of each course, several tests were performed. The first one, made with gravel concrete in 3:8 proportion, did not seem satisfactory because it was too similar to the existing texture. By using small cofferings, we then tried to obtain lighting effects on the facings. We gave this up when it became apparent that these lighting effects were not sufficiently visible. Even after washing, the concrete was too grey, especially on the arch faces exposed to the wind where the stone had been weathered to a somewhat red colour. A permanent solution was found by using a chisel to recut the concrete facing so as to give a hollow of approximately three centimetres. The work was easily performed by the workers on the site. It yielded interesting light effects and the 3-cm hollow creat-

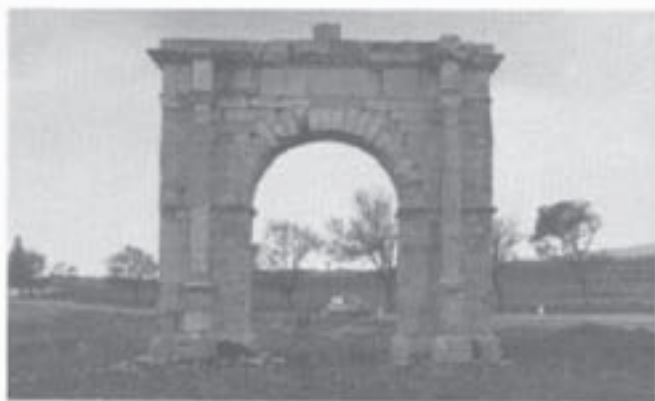
The arch in 1979 [Photo: J. Vêrité].

We do not know how the soffit of the Mustis arch was originally made. It must have been a very difficult operation. The cleaning down of the intrados revealed a warped surface and the fact that the faces of the two keystones had been recut several times suggests that they were also wedged in with pebbles. The tracing of the archstones did not reveal the geometrical shape of the vault (although we know it was not semi-circular but flattened towards the centre). We thought that the intrados had perhaps subsided because of the load. We did not have wood or a carpenter available to make a soffit which could be modified during the setting in of the archstones. So scaffolding made with agglomerated concrete and wood was constructed in the following manner: between the ground level and the arch impost four pillars were erected, each 70 cm in width, their axes located at one quarter of the distance between the jambs. These pillars supported a beam plating on which two walls were built on the façade edge. A few centi-

metres from the estimated final level, a beam plating was set on the two walls and the curve of the soffit was obtained with a cement capping. As we feared, the weight of the soffit produced subsidence of its upper part. But our construction was too mathematical and did not take into account differences of level (up to 5 cm) produced by setting difficulties when the arch was built. After the first mounting and a precise field-glass survey, the archstones were taken down and the capping corrected according to the previous data. Then the archstones were replaced on the soffit, adjusted and set according to the usual method.

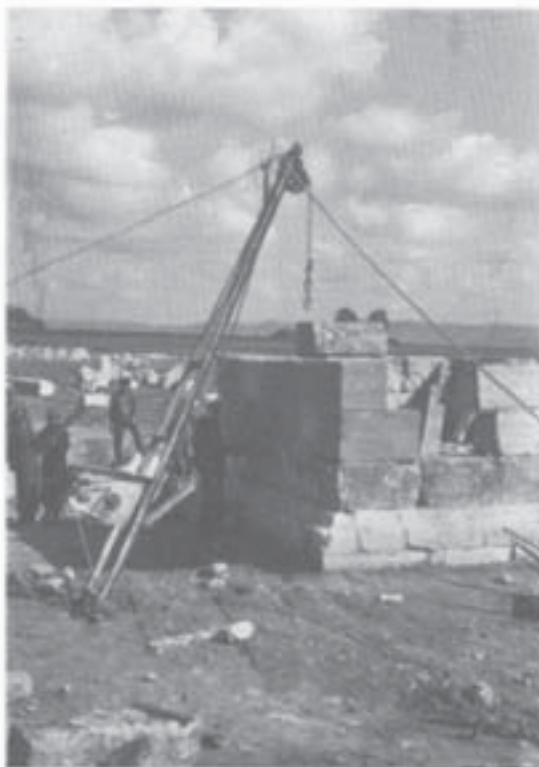
The tripod used at the Julii Mausoleum—two 'stones' made of gravel concrete (3:8) [Photo: J. Vêrité].

This was the Julii mausoleum located near the Mustis arch. The analysis of stones found on the ground indicated that several of them belonged to that monument and that two courses could be restored. The building was not very high, and it seemed interesting to test the possibility of rebuilding it with a tripod as was done in Roman times. There was a crab on one of the legs of the tripod upon which a winch could be set. With the help of the leg, fixed in place with rope, the mausoleum was restored.

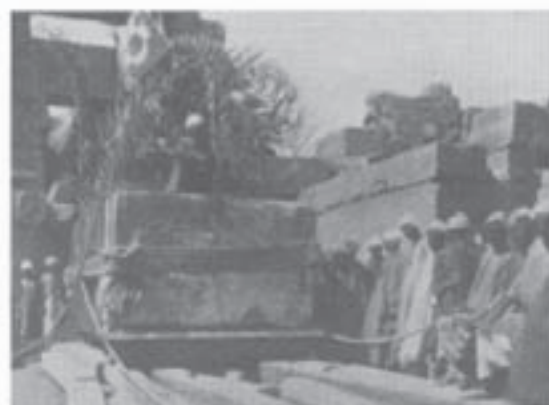
Architrave being dismantled [Photo: CNRS].

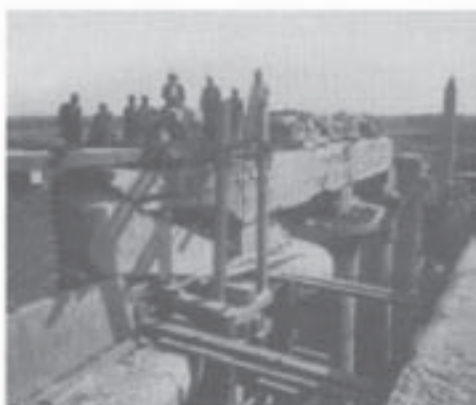
Upper portion of scaffolding, twenty metres high [Photo: CNRS].

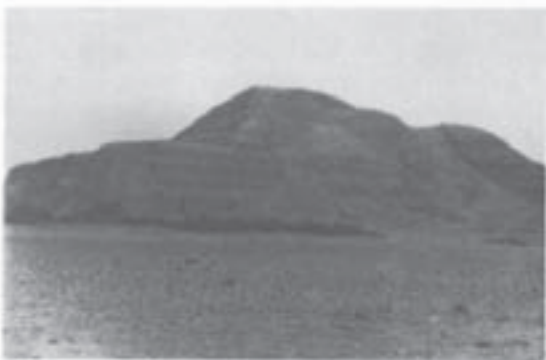
Pyramid built of mud bricks. The Huaca del Sol is 250 metres long by 50 metres high [Photo: R. Samáñez Argumedo].

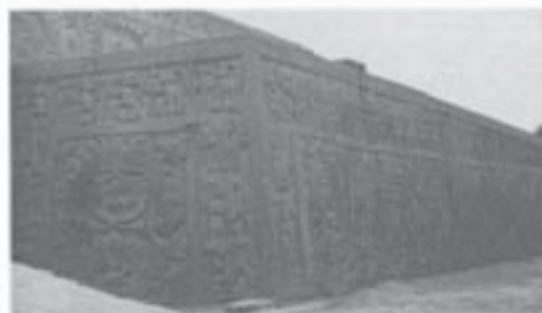
The Huaca del Dragon, built in 900 B.C. in the Moche valley, near Trujillo. This pyramid, almost completely covered with decorative motifs, was restored in 1966.

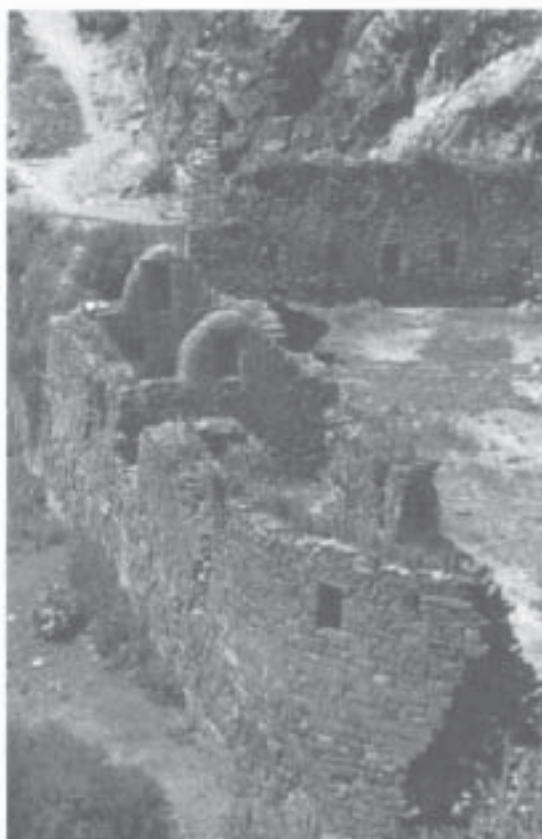
Inca constructions at Pancartambo near Cuzco: superposed mud bricks with gabled terminations that are placed above the stonework [Photo: R. Samánez Argumedo].

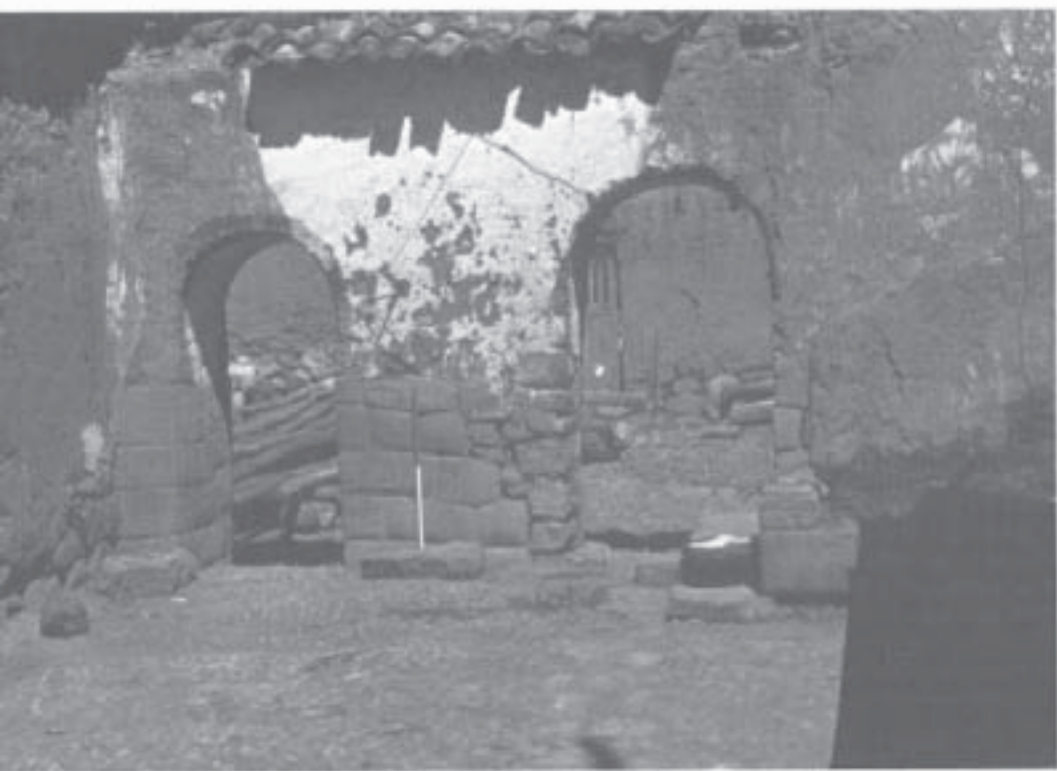
Colonial buildings with mud-brick arches superposed on stone walls built by the Incas. This demonstration of cultural symbiosis is frequently seen [Photo: R. Samánez Argumedo].

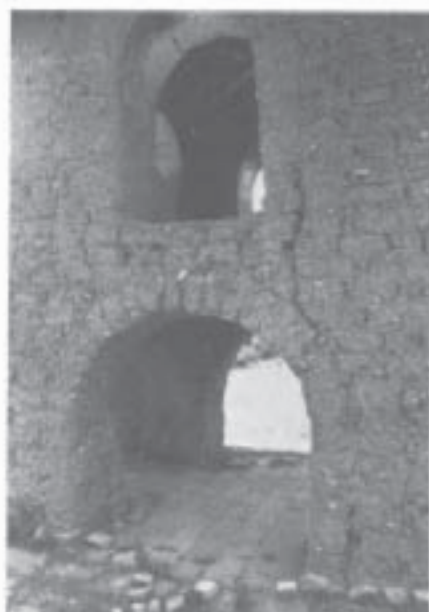
The mud bricks of the colonial period differed from those of pre-Columbian times in the manner of preparation and the use of formal building elements such as the arch [Photo: R. Samáñez Argumedo].

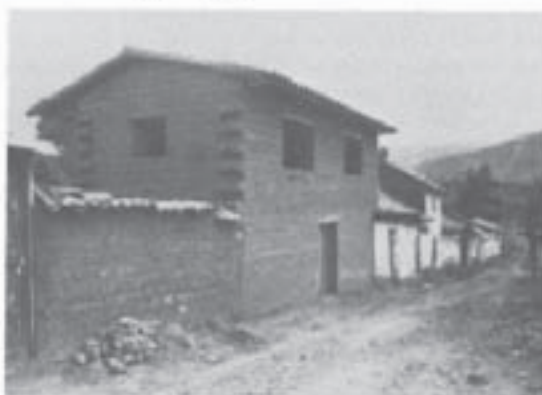
Recent construction using mud bricks. This two-storey structure follows ancient building methods. Moreover, use is made of the only material within the financial reach of the majority of Peruvians [Photo: R. Samáñez Argumedo].

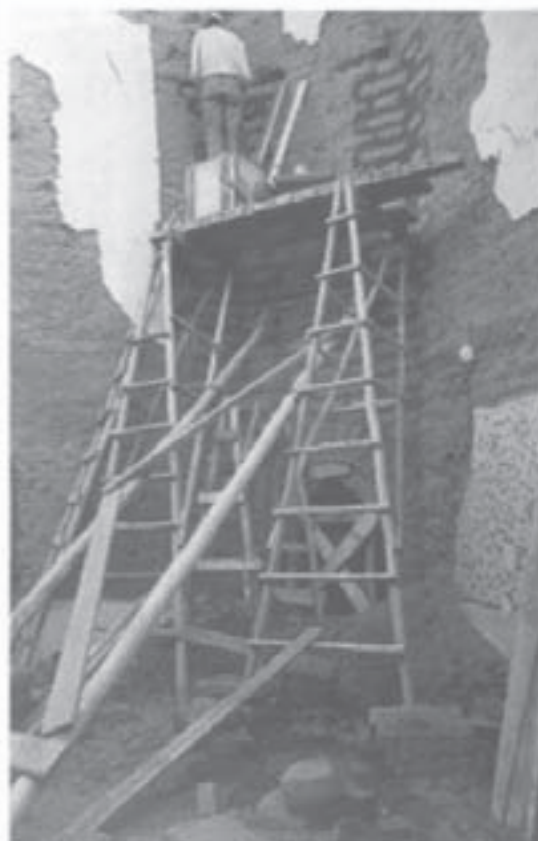
Fitting new mud bricks into a wall in order to repair vertical cracks, producing a 'seam' [Photo: R. Samáñez Argumedo].

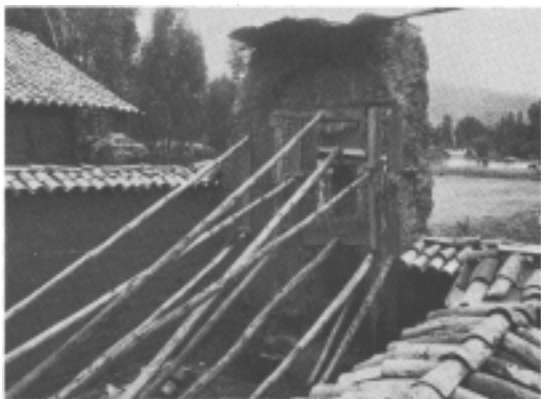
Bracing and external supports for a section of wall having vaulted niches with designs in relief and paintings of a seventeenth-century altarpiece. Lateral chapel of the church of San Jerónimo near Cuzco [Photo: R. Samáñez Argumedo].

Special operations to preserve portions of walls, when these are extremely deteriorated or when there are architectural elements such as niches, windows or decorative elements such as figures in relief or mural paintings. A number

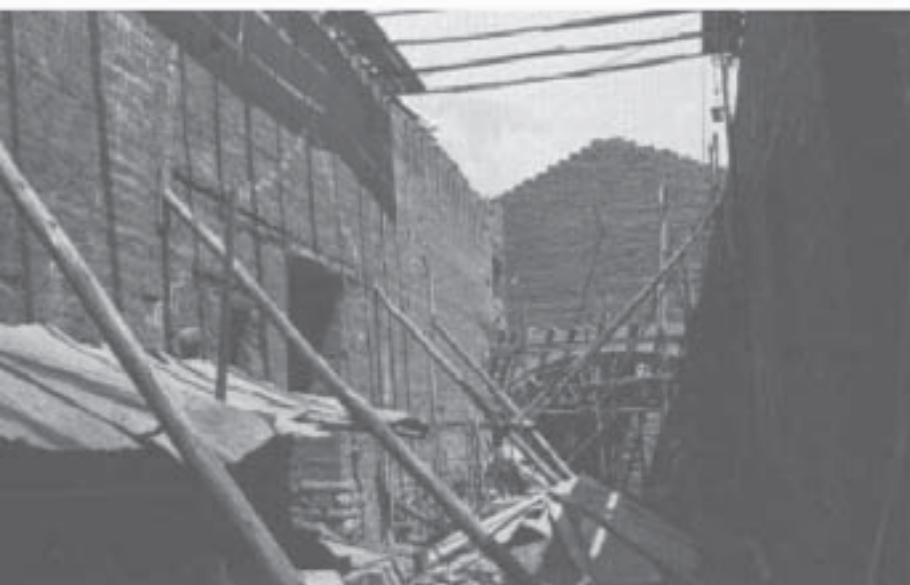
Interior of the church of the Colegio de San Bernardo during the restoration work. Placement of a special reinforced-concrete structure inside one of the mud-brick walls [Photo: R. Samánez Argumedo].

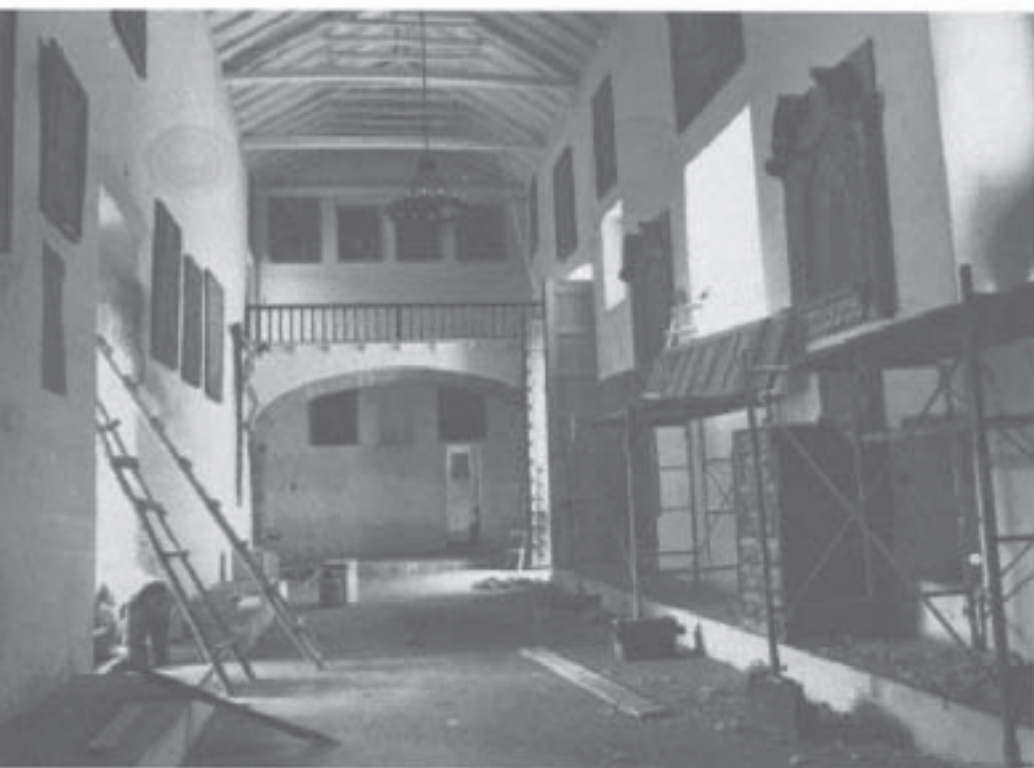
Among the construction features worthy of note is the fact that the columns had a cross section of 40 × 80 cm, being almost cross-shaped, receiving a coating of plaster 2.5 cm thick on both the faces in contact with the mud bricks. The other two surfaces in contact with the wooden bonding-keys were covered with sheets of expanded polystyrene

5 cm thick. The wooden beams for bracing the mud-brick walls were joined to the columns through five 3-metre-long bonding keys distributed on both faces of the wall along its entire height.

The columns poured into the mud-brick structure were rectangular on the side facing the wall and octagonal towards the sides. This special design permits the reinforced concrete to support the mud-brick mass without striking it and without producing concentration of stresses. Experience has shown that the blow of the reinforced concrete against the mud-brick structure is due to the existence of a small space between the two materials. Impact effects have been reduced to a minimum through construction features which ensure firm contact between the two materials. This also guarantees the transmission of horizontal forces at the contact interface.

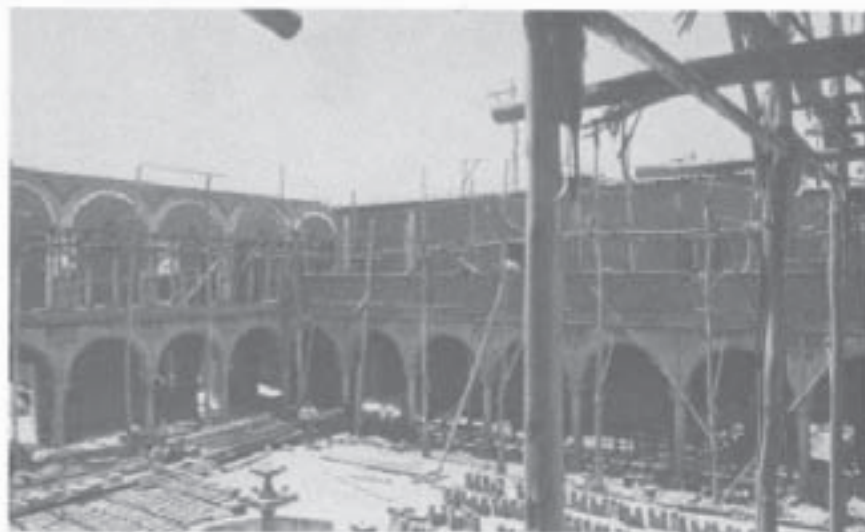
Replacement of the mud-brick wall to close one of the sides of the patio of the Palacio del Almirante in Cuzco. To enable the wall to withstand later stresses during earthquakes, it was reinforced with vertical wooden beams. Note the 'U' shape of the mud bricks which were specially made to hold the beams in place [Photo: R. Samánez Argumedo].

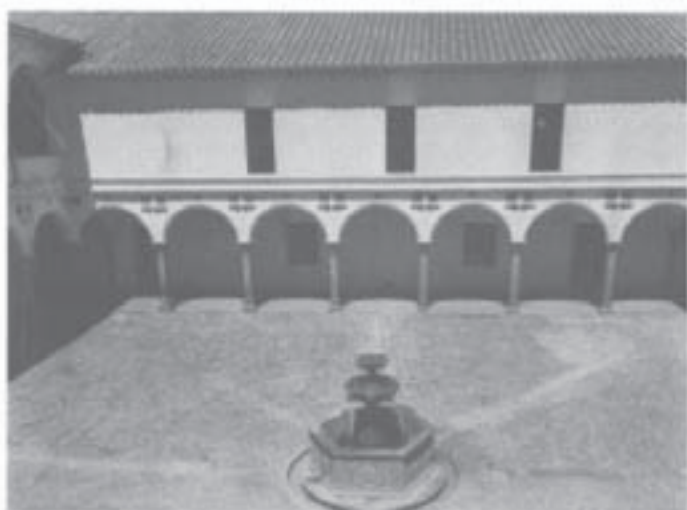
The same view of the patio of the Palacio del Almirante in Cuzco, after completion of the restoration work [Photo: R. Samánez Argumedo].
